## Case Study

# Removal of old dental bridge and remaining teeth. Restoration of 3 implant-supported teeth, patient aged 50+

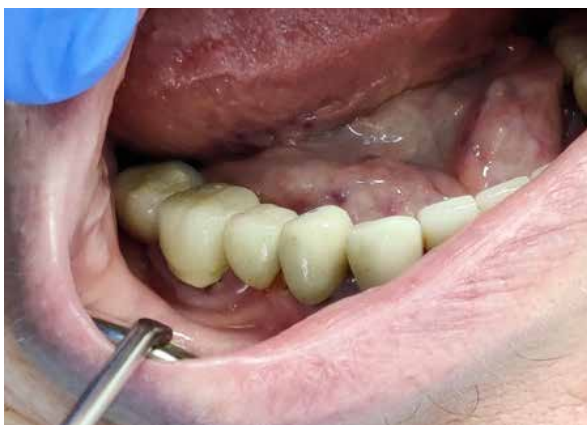
*Photo of the initial situation – the bridge must be removed*

The initial situation is shown in the photo below. It is clear that the soft tissues have recessed as a result of restoration: dental bridge is not held securely, supporting teeth are destroyed and must be extracted.

At the next stage, teeth roots and remains were extracted in the most atraumatic way possible in order to preserve the septum between the roots of the teeth and avoid damaging the bone wall on the vestibular side.

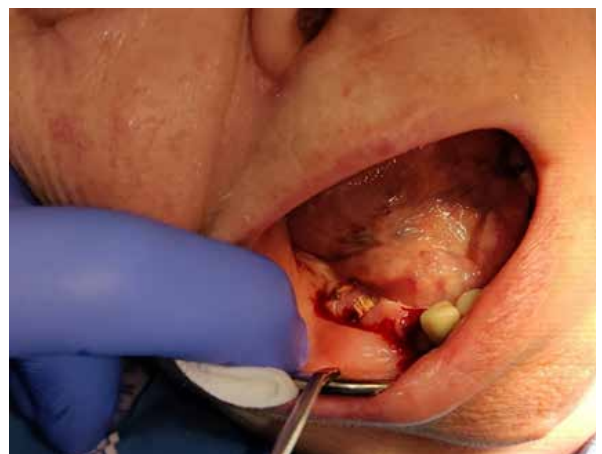
*Extraction of remaining teeth*

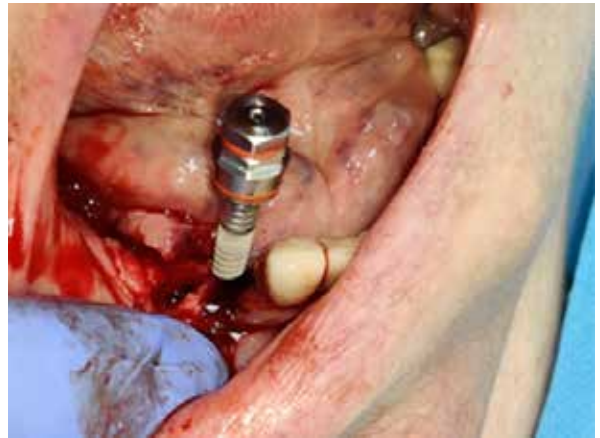
Implant placement in the lower jaw

Next, the flap was detached and three implants were placed in position of teeth 45, 46 and 47.

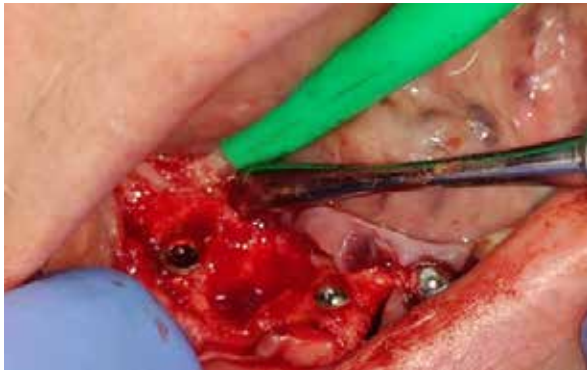
All three implants were placed in position of teeth 45, 46, 47

- UH8 Pure&Porous Implant Ø4.2 L11.5 Internal Hex RP - in position of tooth 45

- UH8 Pure&Porous Implant Ø4.2 L10 Internal Hex RP - in position of tooth 46
- UH8 Pure&Porous Implant Ø4.2 L8 Internal Hex RP - in position of tooth 47
- Healing caps (gingival height 3 mm) for internal hexagon - 3 pcs.

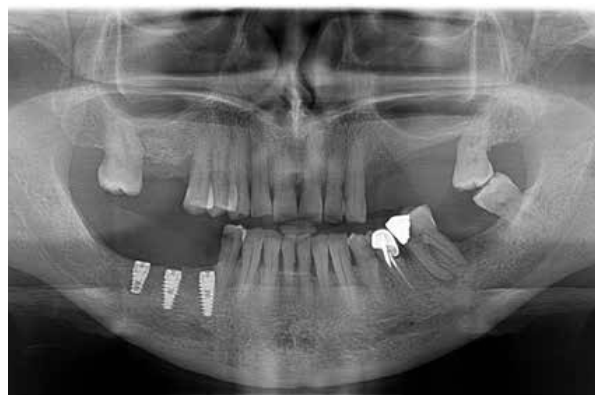
X-ray immediately after implant placement

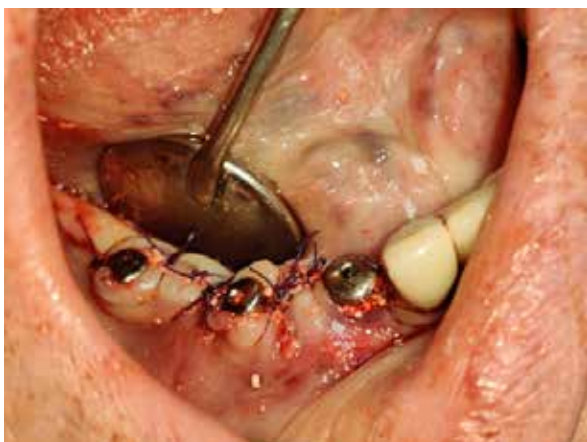
Healing caps are installed and soft tissues are sutured

At the next stage, healing caps were installed into the implants and soft tissues were sutured around them. They were left in this state until osseointegration was complete and new gingival cuffs were formed.
