Case Study

Single implant screw-retained restoration after extraction of a tooth affected by cystic granuloma

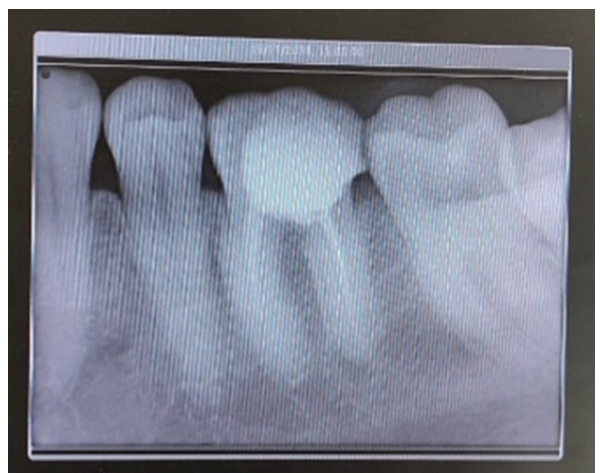
X-ray of a problematic tooth

X-rays showed cystic granuloma, the tooth was destroyed and had to be extracted.

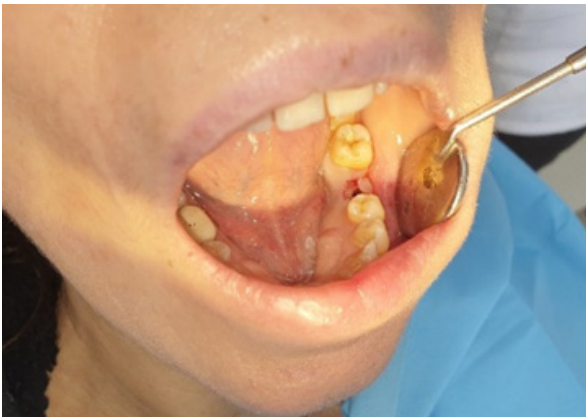
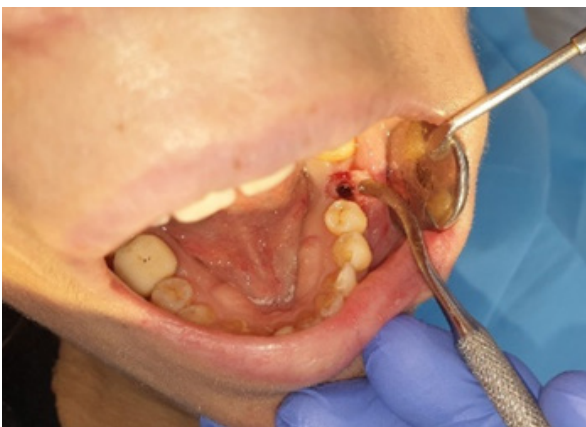
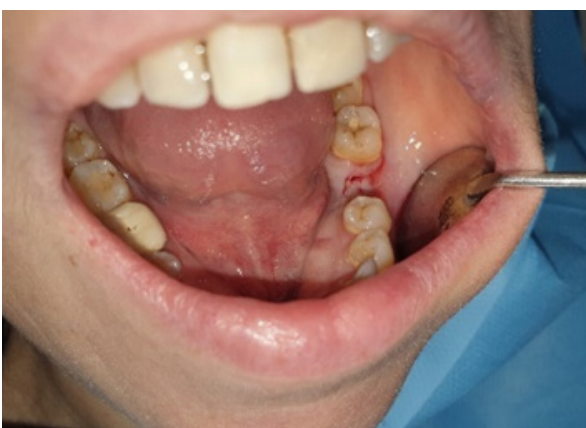
Healing cap placement and the patient's condition when the implant placement surgery was complete

5. Next, a healing cap was placed into the implant, and the soft tissues were sutured until complete osseointegration.
6. After a period of osseointegration, the gingival cuff was formed using a healing cap.

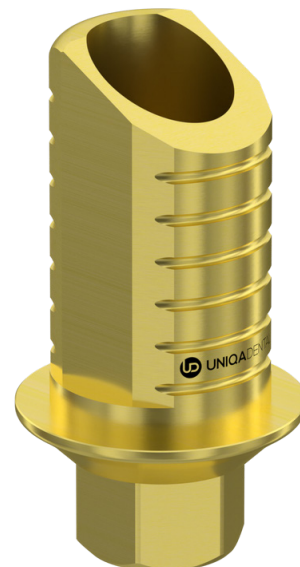
Ti-base abutment for screw retention of the prosthesis with anti-rotation elements

The restoration was screw-retained to reduce the risk of soft tissue inflammation due to contact with residual cement. For this purpose, an abutment with anti-rotation elements was chosen. The crown is made of zirconium, the material is durable and the risk of chipping even in such a loaded area as tooth 36 is minimal.
